January 11<sup>th</sup>, 2023

**This Inspection notice affects all Buckingham PN 5007R1 and PN 5007R2 BuckRigger™ Blocks (Fig. 2a – 2b) manufactured prior to December 2022.**

**Buckingham Mfg. Co**

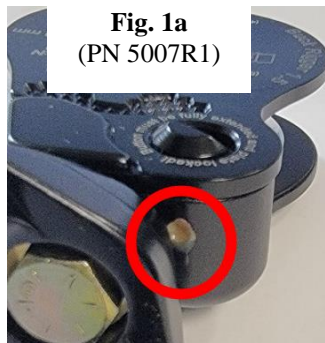
**Fig. 1a**  
(PN 5007R1)

Buckingham Mfg. Co. has been notified by a contract supplier, that the button assembly on a limited number of Buckingham PN 5007R1 and PN 5007R2 BuckRigger™ 1.5 blocks (Fig. 1a – 1b) may not be secure. If the button comes out the side plate can open, allowing the rope to fall out which can result in serious injury or death. It was discovered that a small number of pulleys may not have had adequate thread locker or sealant, allowing the set screw to back out. Under normal circumstances, either the thread lock or sealant is adequate to secure the button and prevent this issue.

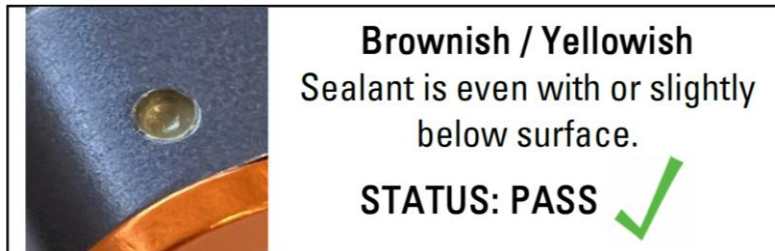
1. Identify the location of the set screw on the BuckRigger™ block, PN 5007R1 and 5007R2 and compare your block to the images below. Does your block have the sealant present and properly applied? The sealant should be brownish yellow to white / grey in color and be even or slightly below the surface of the aluminum body (Fig. 4a – 4b). If **“YES”** no further action is required.

Note: If the sealant is the proper color and is filling the hole as shown in Fig. 4a – 4b, but there is excess sealant on the surface of the aluminum body, this is not a failure. Sealant above the surface is referring only to the sealant in the hole extending above the surface (which could indicate an improperly installed set screw) and not spilled or overflow of the sealant.

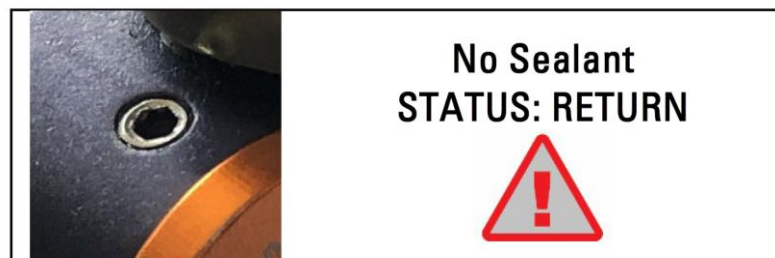
Fig. 5a

If **“NO”** (Fig. 5a – 5b), remove the equipment from service and notify your Supervisor, Safety Director and contact Buckingham immediately at 1-800-937-2825 for return instructions.

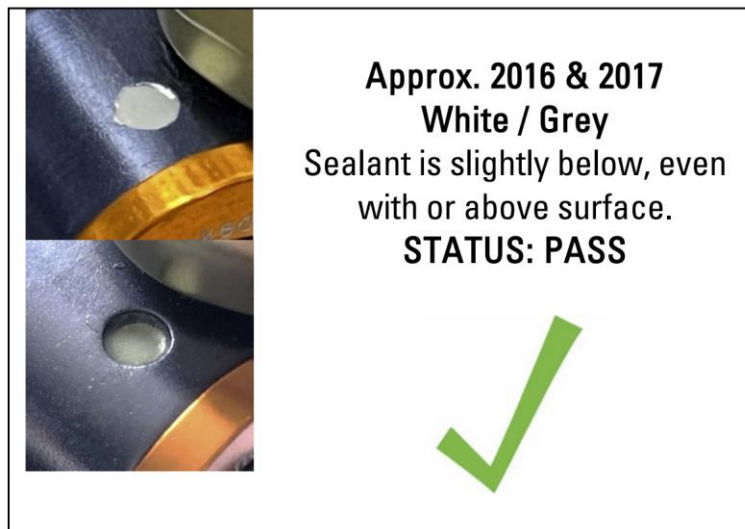
Fig. 6

1. Identify the location of the set screw on the BuckRigger™ block, PN 5007R1 and 5007R2 and compare your block to the images below. Does your block have the sealant present and properly applied? The sealant should be white / grey in color and be slightly below, even with or above the surface of the aluminum body (Fig. 6). If **“YES”** no further action is required.

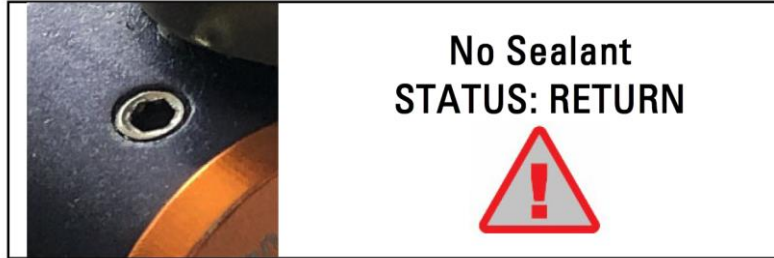
Fig. 7

If **“NO”** (Fig. 7), remove the equipment from service and notify your Supervisor, Safety Director and contact Buckingham immediately at 1-800-937-2825 for return instructions.

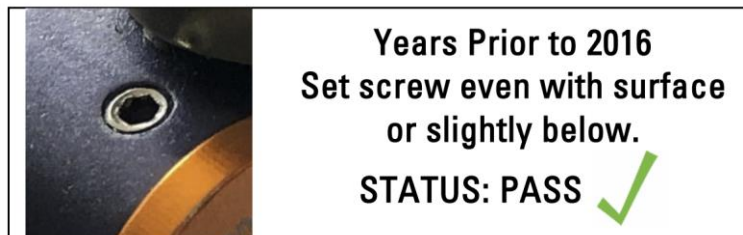
Fig. 8

1. BuckRigger™ manufactured prior to 2016 were made differently. The button set screw has thread lock but no sealant on top of it. Identify the location of the set screw on the BuckRigger™ block, PN 5007R1 and 5007R2 and compare your block to the images below. Is the set screw even with or slightly below the surface of the aluminum body (Fig. 8). If **“YES”** no further action is required.

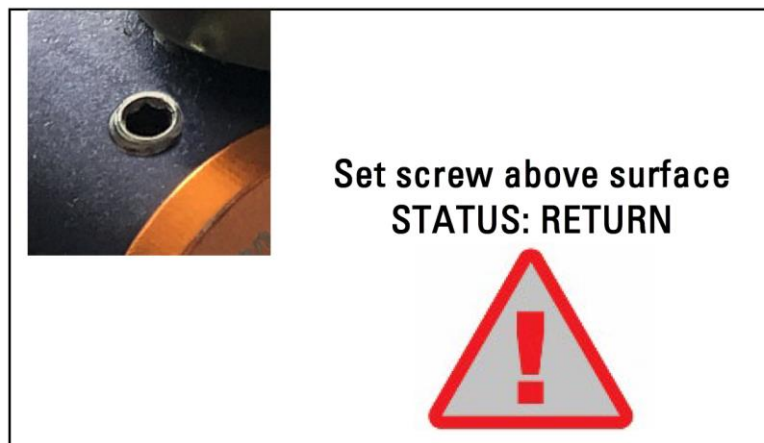
Fig. 9

If **“NO”** (Fig. 9), remove the equipment from service and notify your Supervisor, Safety Director and contact Buckingham immediately at 1-800-937-2825 for return instructions.
